| Glasfaser-Flugzeug-Service GmbH Hansjörg Streifeneder Hofener Weg 72582 Grabenstetten | Technical Note No. 205-22 No. 206-21 | Page: 01/ 02 F.R.G. Type Certificate No. 304 |

Subject: Rudder gimbal drive
-rear actuator arm-

Affected: Sailplane model „Club Libelle“ F.R.G. Type Certificate No. 304
 Sailplane model „Hornet“ F.R.G. Type Certificate No. 304
 Sailplane model „Hornet C“ F.R.G. Type Certificate No. 304

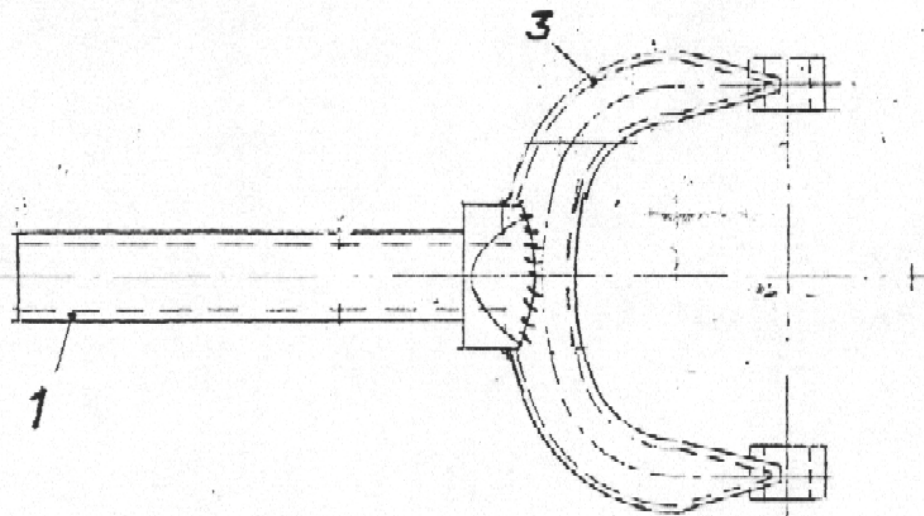
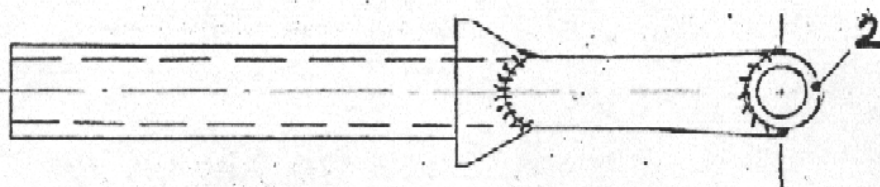
Reason: Failure of the actuator arm caused by loads applied when regularly
lifting the fuselage by ist rudder and/or when fuselage has broken.

Actions: The faulty part, made according to drawing No. 203-45-10, must be
replaced by an improved actuator arm, made in accordance with
drawing No. 203-45-10-2
Working instructions:

- 1 off rudder actuator arm made according to drawing 203-45-10-2
- 1 off M4 stop nut
- 3 off Split pins, 1.5 x 16 mm
