Subject: Elevator Linkage at the base of the stick

Affected: Glider-Model BS-1
All Works Nos.

Reason: Failure of 2 Linkages

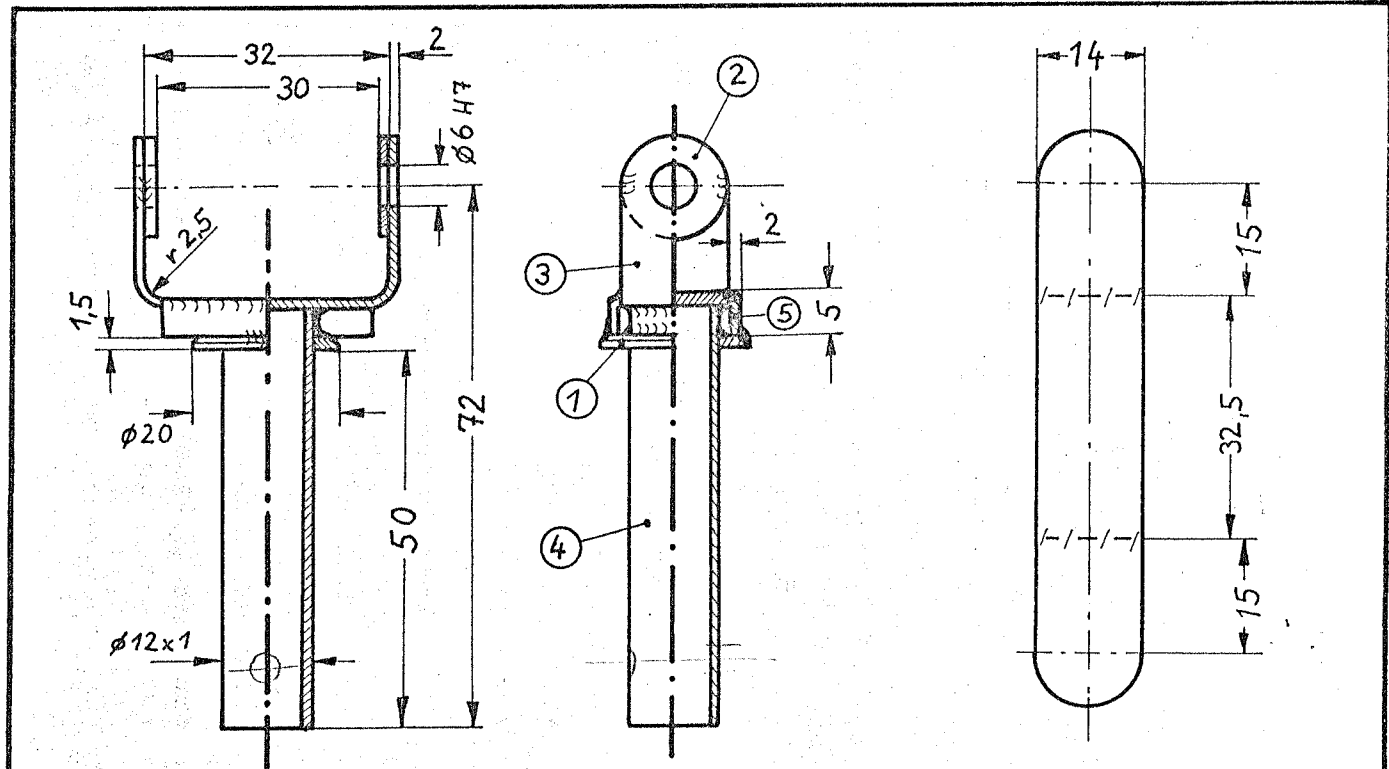
301-41-3/2a

Action 1: The Elevator Linkage at the base of the stick (see modified drawing No. 301-41-3/2a) must be inspected carefully for possible cracks near the welded seam.
This inspection must be made immediately and again following the application of high loads to the glider (e.g. hard landings or ground loops).
If cracks are found the glider must not be flown until the defective part has been replaced.

Action 2: The Elevator Linkage at the base of the stick must be replaced by a modified part in accordance with drawing No. 301-41-3/2a.
Replacement must in all cases be effected before next periodical inspection.

Wärmebehandlung:
Anlassen in Schutzgas
1 Std. bei 550°C
