Affected : Sailplane model " BS 1 "
- all serial numbers -

Subject : Rudder gimbal drive
- rear actuator arm -

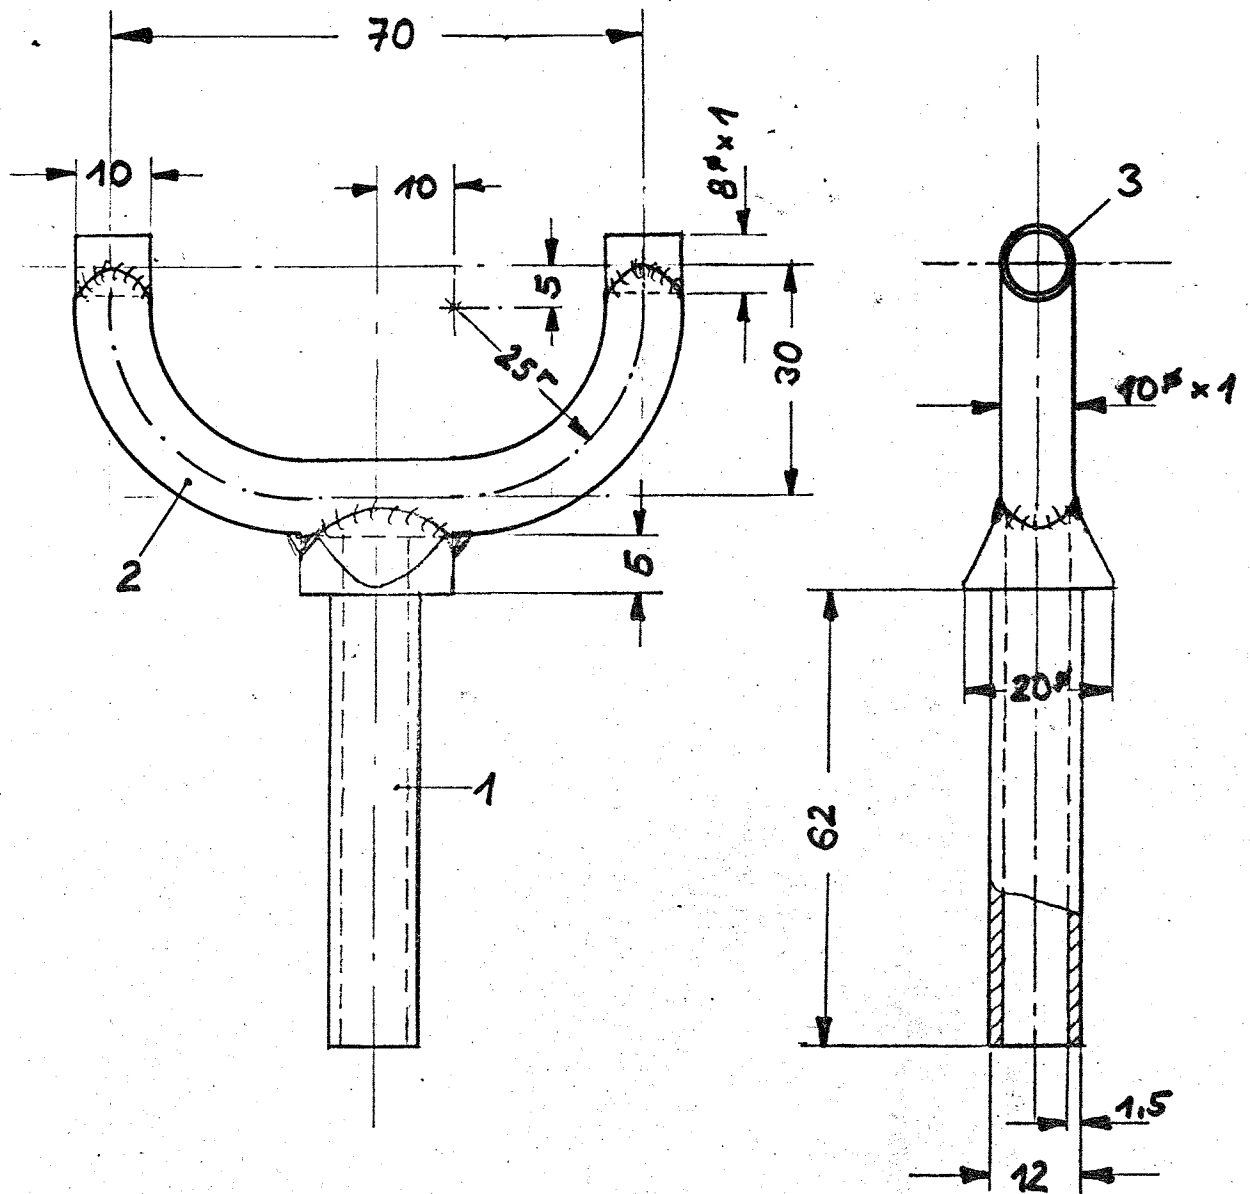
Reason : Failure of the actuator arm caused by loads applied
when regularly lifting the fuselage by its rudder.
and/or when fuselage has broken.

Actions : The faulty part, made according to drawing No. 301-45-10,
must be replaced by an improved actuator arm, made in
accordance with drawing No. 301-45-13.

Only genuine parts made in accordance with drawing No. 301-45-13 must be used.
