<u>Sailplane model:</u>	H 301 Libelle und H 301 B	ATC No. 251
	Std.Libelle, Std.Lib. 201 B, Std.Lib. 203	251
	Club Libelle 205 und Hornet	304
	Kestrel	276
	Glasflügel 604	281
	BS 1

Subject : Glass fiber laminate covering the spar stub fittings

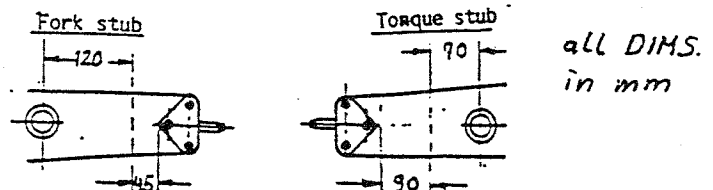
2. If corrosion was found on the fitting, proceed as follows:  
First remove gelcoat from spar stub (if such was applied by the manufacturer) and remove laminate as shown in the sketch (such preparing the area to be scarfed later on) -

make sure that the spar flange rovings and the laminate connecting the upper and lower stubs halves are never been sanded. Furthermore remove any laminate adhering to the fitting.

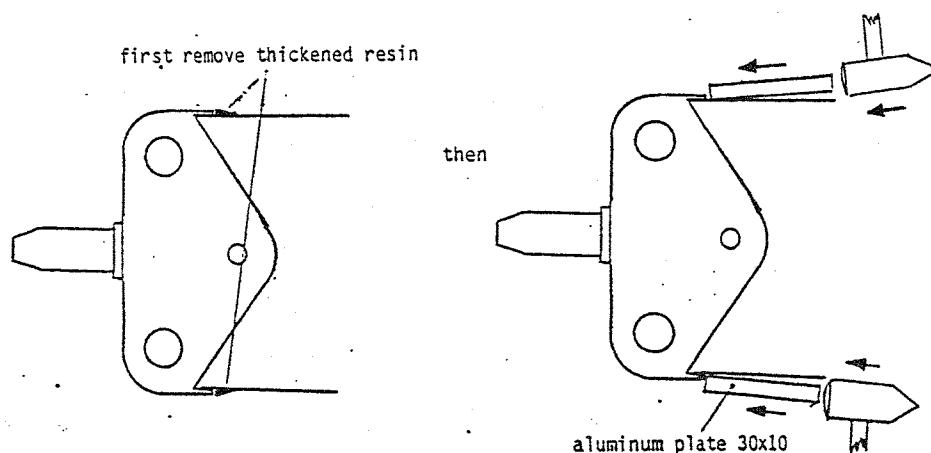
If there is suspicion that there is corrosion on the inner side of the fitting, it has to be removed as follows:

Drive out hollow rivets imbedded in the spar flanges - but make sure that a counter weight is held against the driving force, Thereafter, with rivets removed, carefully loosen and extract the fitting with the aid of an aluminum plate - see sketch.

Next sandblast the fitting (Using only approved material) and apply a fresh corrosion protection. Then carefully smooth the spar stub (using a 400 grid sand paper), apply a thin coat of resin, push fitting fully home and install hollow rivets. The step between fitting and stub and between connecting glass layers should be filled up using thickened resin.
